# RESEARCH MEMORANDUM

LANDING AND TAXIING TESTS OVER VARIOUS  
TYPES OF RUNWAY LIGHTS

By Robert C. Dreher and Sidney A. Batterson

August 26, 1958

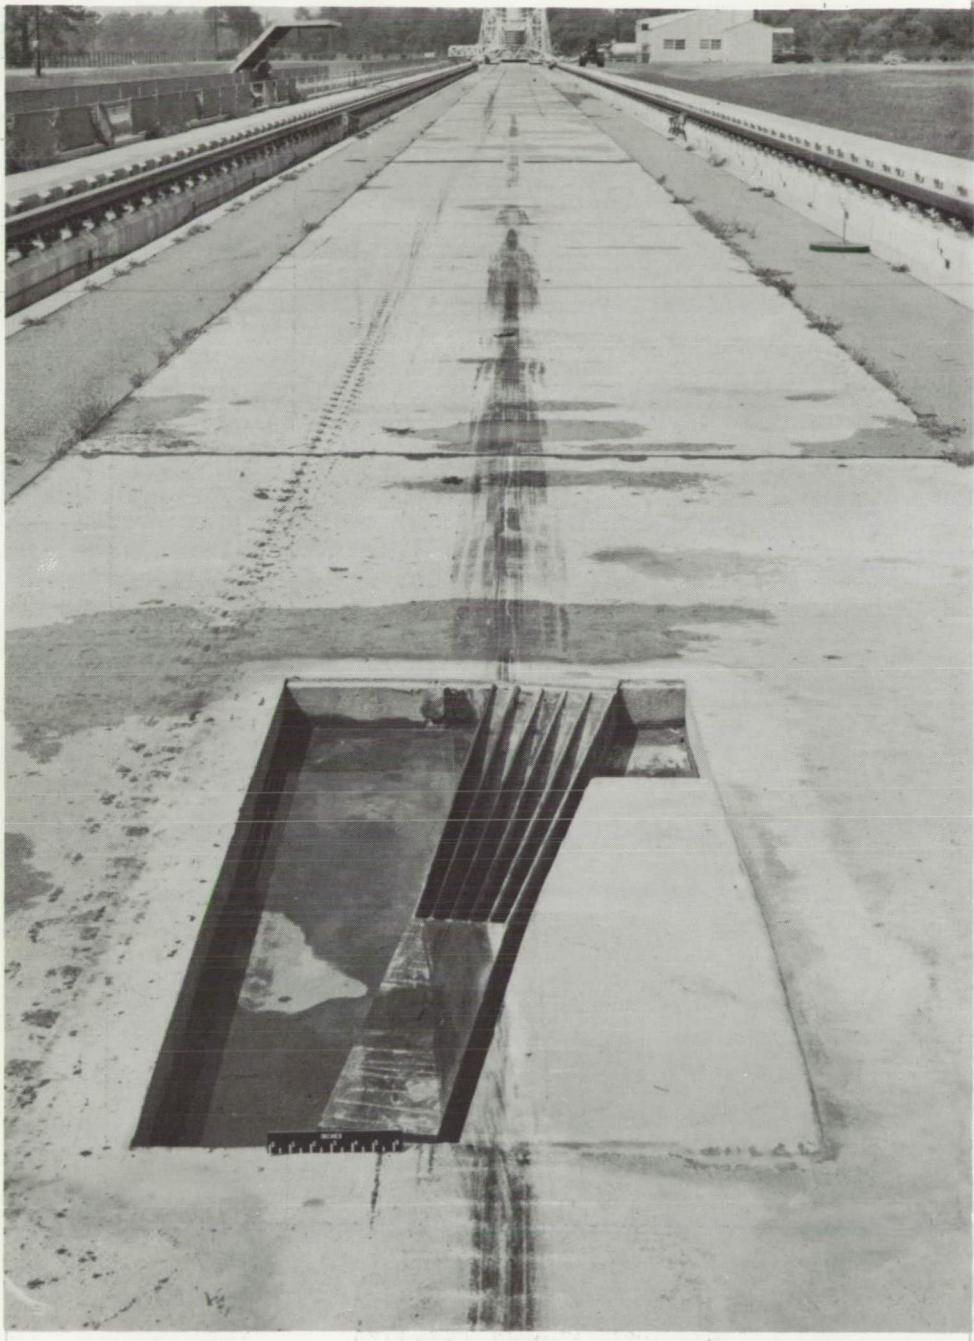
L-57-3688

High-speed moving pictures (1,000 frames per second) showed rather violent yawing oscillations of the wheel during the tests in which the light was yawed and initial touchdown occurred either on the grating or less than a foot in front of it. In this group of tests, the largest oscillations occurred during the yawed wheel landings. Figure 20 is a photograph of the track made by the wheel during one of these runs and shows that the landing gear experienced a considerable amount of side deflection while passing over the light.

Figure 20.- Photograph of track left by F-94C nose-landing-gear wheel while negotiating yawed Elfaka light (position C). (Wheel entered light at grating.)

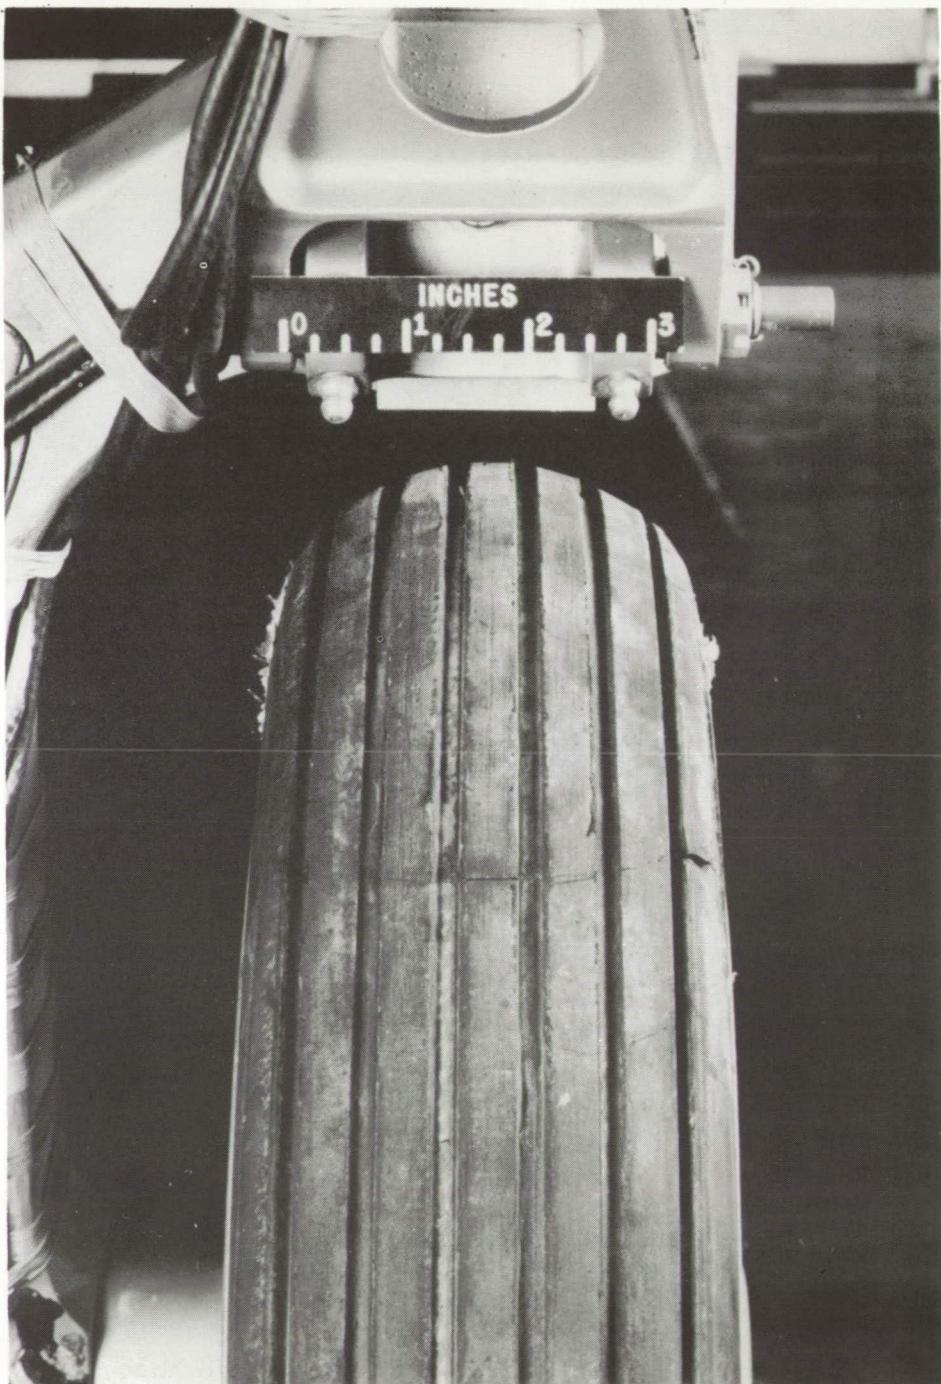
L-57-3669

AGA expendable-top edge light.- One taxi test was made over the AGA expendable top light. The loads developed in the landing gear while rolling over this light were small, however, some tire damage occurred during this run. Figure 23 is a photograph of the tire taken immediately after the run and shows the cuts caused by rolling over this light. Figure 24 is a photograph of the light taken immediately after the test.

Figure 23.- Cut in F-94C nose gear tire caused by taxiing over AGA expendable-top light.

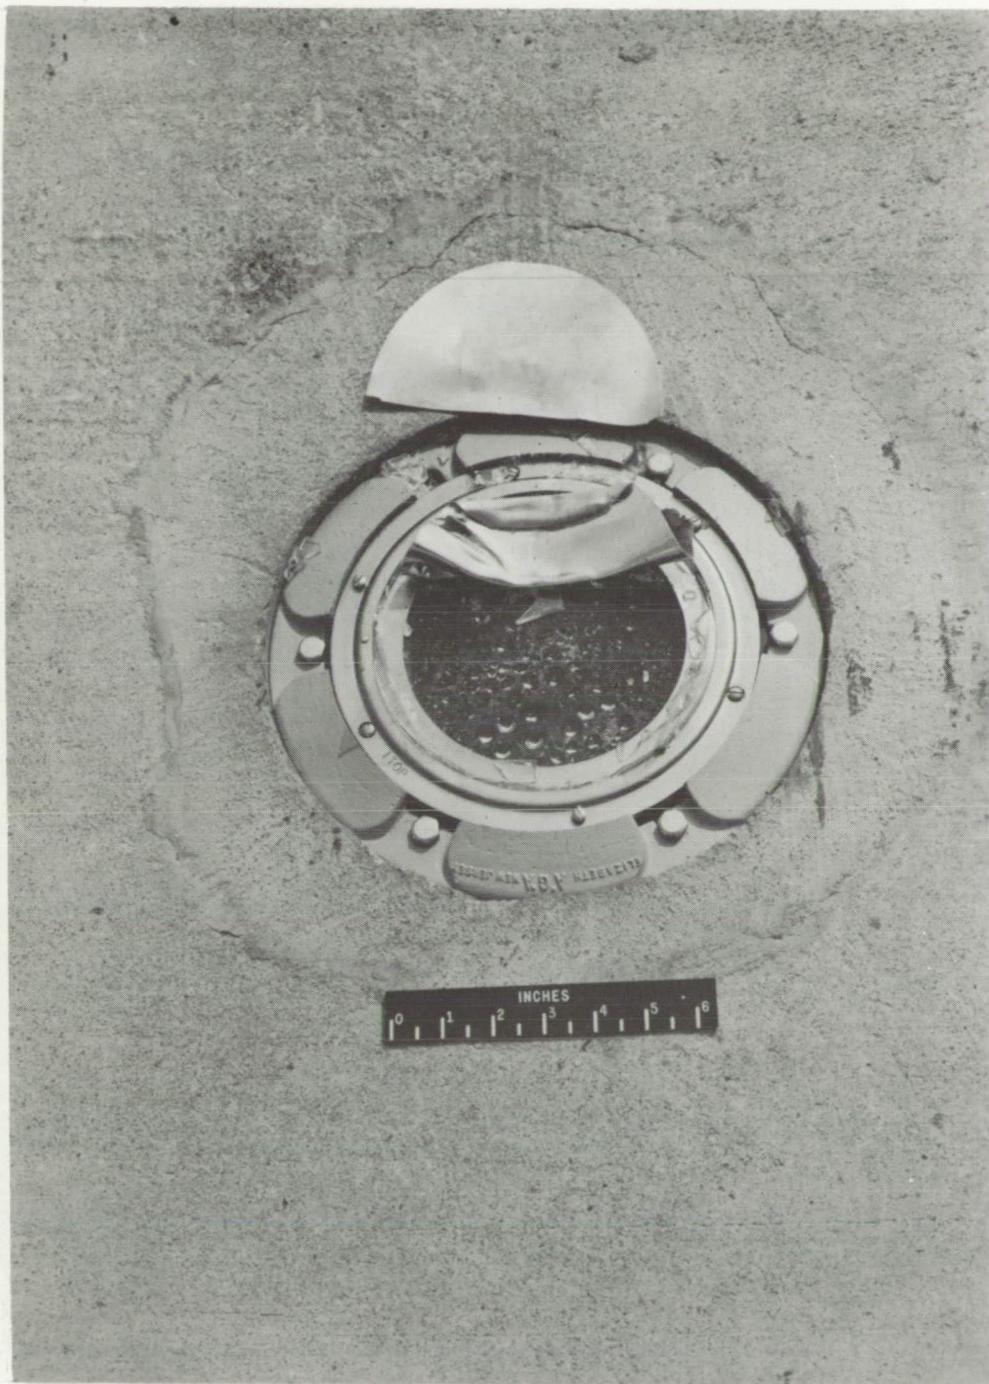
L-57-3672

Figure 24.- AGA expendable-top light after F-94C nose wheel roll-over test.
